February 14, 2013

Re: CCC No. 81 - Window and Sliding Door Replacement Feasibility Study
370 Dominion, Ottawa, Ontario
exp Reference: OTT-00208613-B0

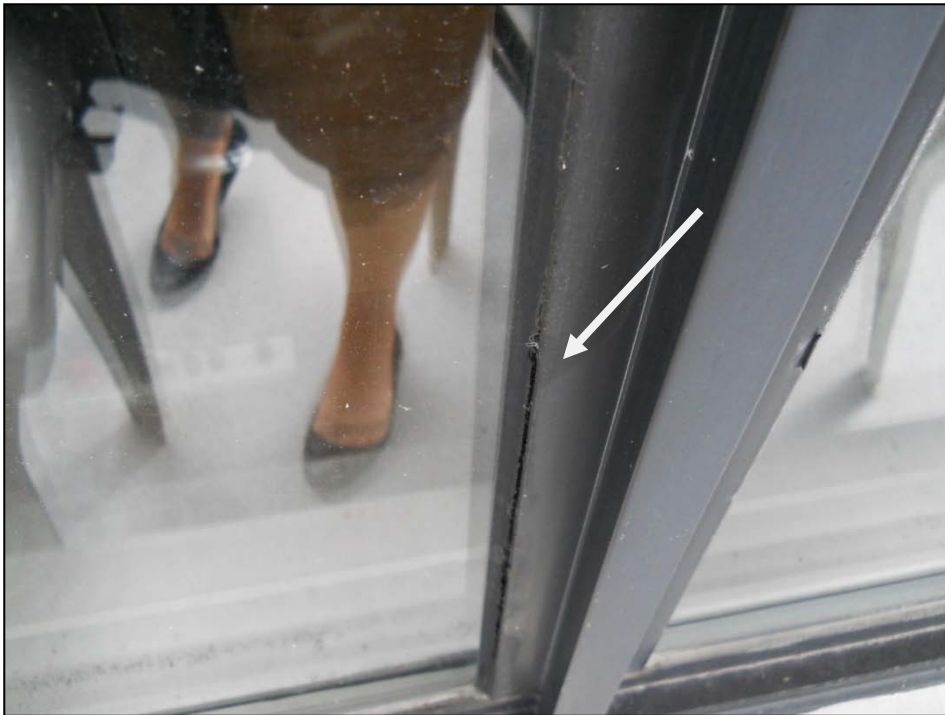
- An additional heel bead sealant was added at the glazing-to-frame junctions. In most cases this heel bead sealant has failed (Photograph 1).
 - The glazing reviewed was all stamped 1974 (original to construction).

Photograph No. 1: Failed heel bead sealant at glazing-to-frame junction - Suite 407

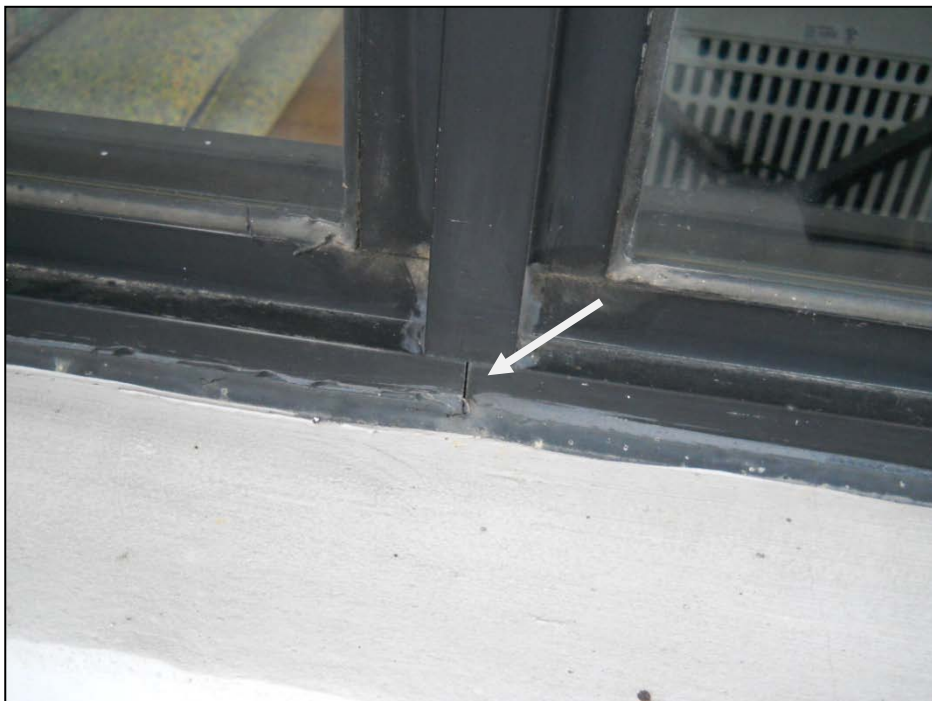
- The joints in the aluminum framing have opened up and the seals within the joints appear to have failed (Photographs 2 and 3).
 - A crack in the aluminum was noted at the bedroom operable unit (Photograph 4).

Photograph No. 2: Failed sealed joints within aluminum frame - Suite 407

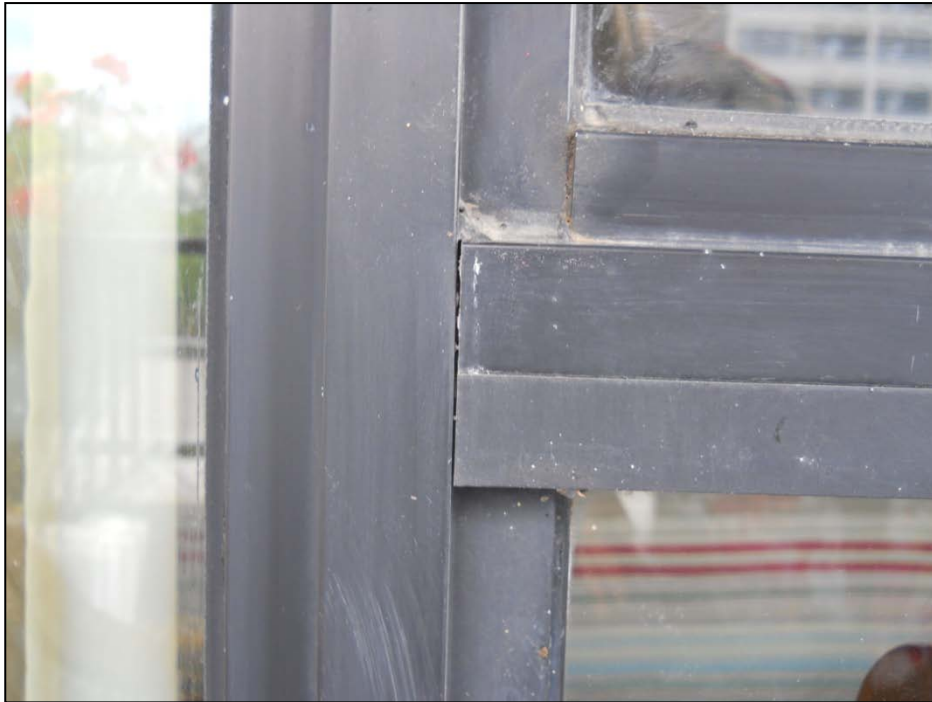
Photograph No. 3: Failed sealed joints within aluminum frame - Suite 407

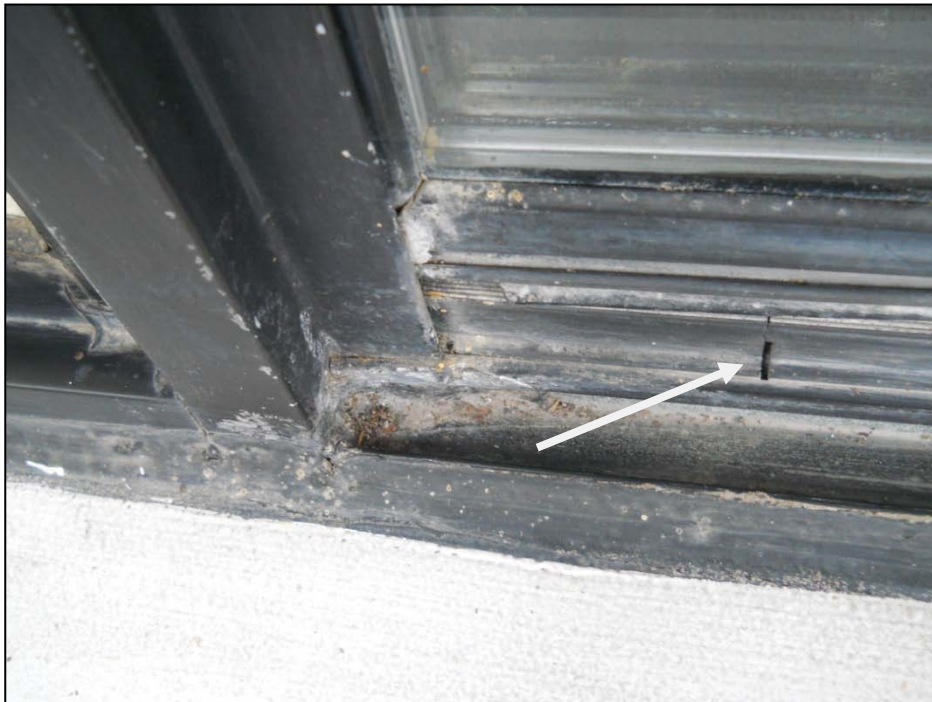
Photograph No. 4: Crack in aluminum frame in operable section - Suite 407

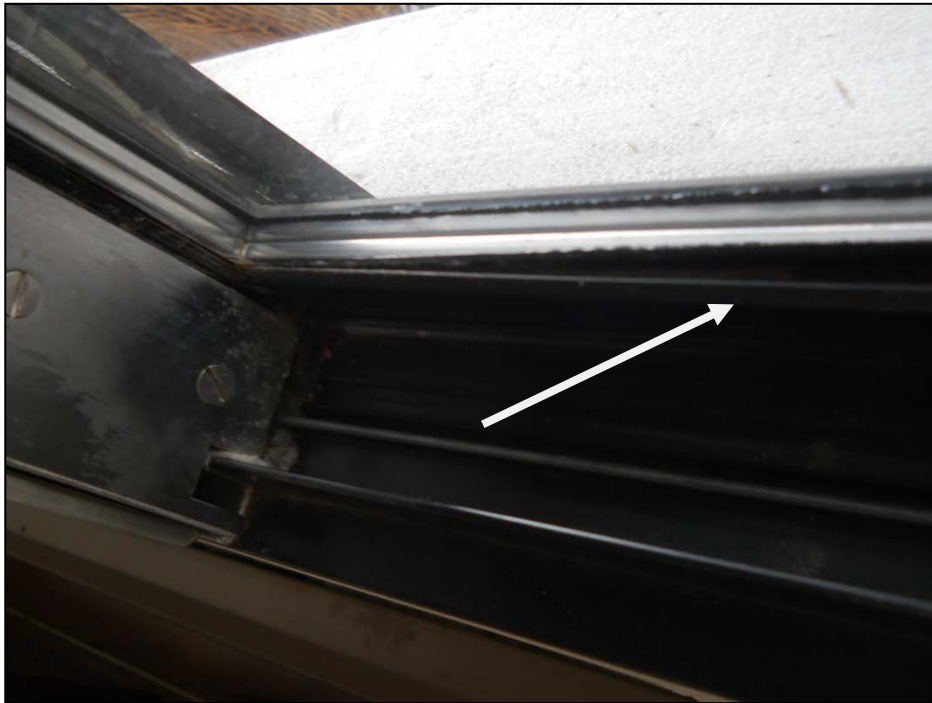
- The frame for the bedroom operable window is bowed inward (Photograph 5).
 - The sealant at the frame-to-wall connection is brittle and cracked (Photograph 6).

Photograph No. 5: Aluminum frame in bedroom bowed inward - Suite 407

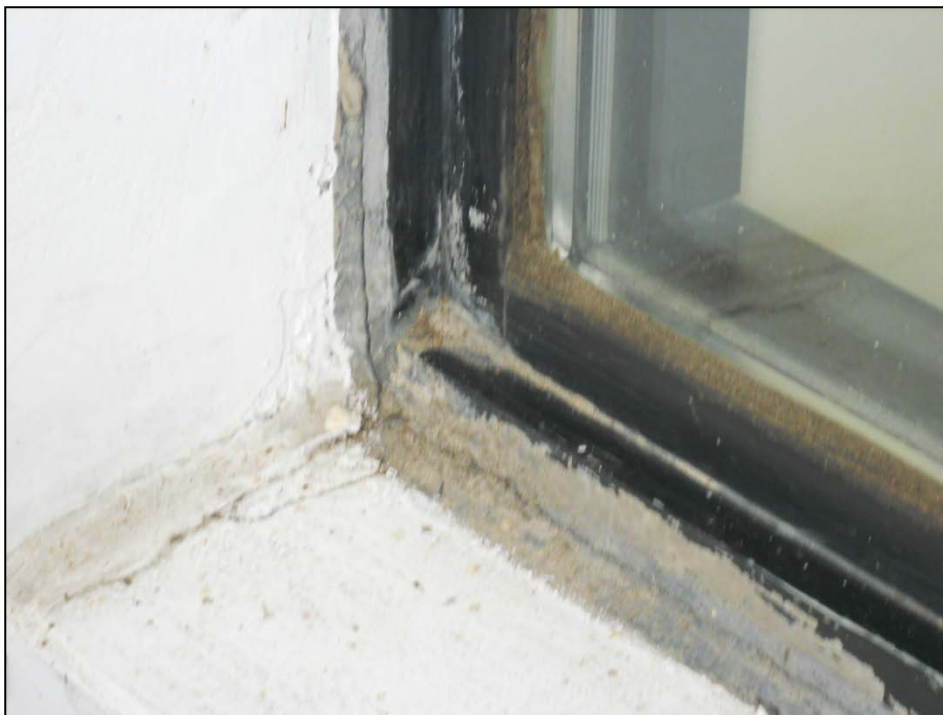
Photograph No. 6: Sealant at frame-to-wall connection brittle & cracked - Suite 407

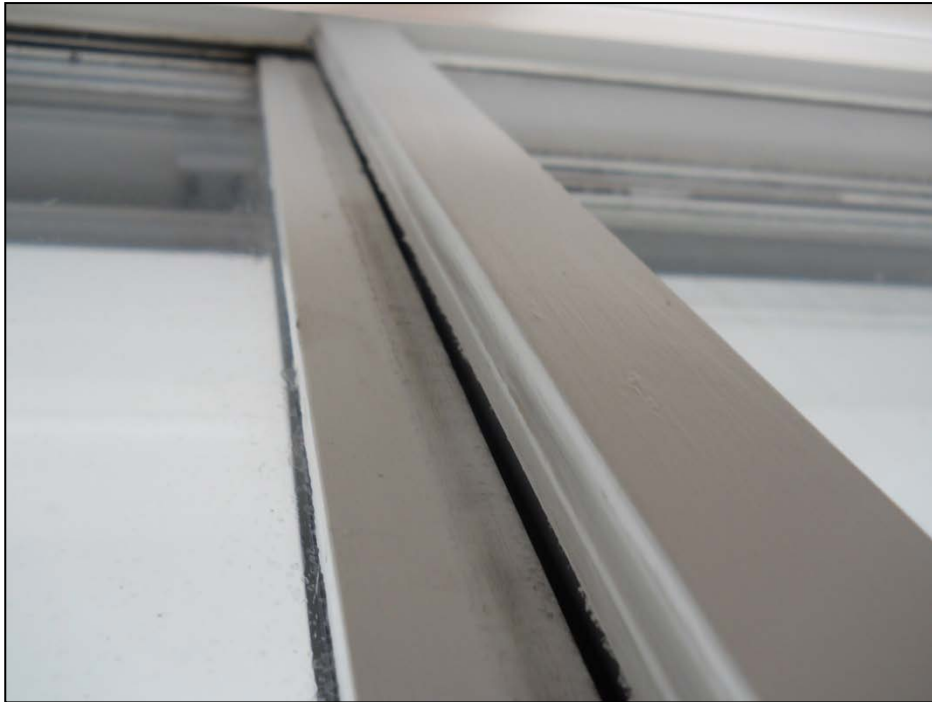
- The operable sliding door was out of square in relation with the frame. When the sliding door is in the closed position there is a gap at the bottom of the opening in comparison to the bottom (Photograph 7).

Photograph No. 7: Operable sliding door out of square – Suite 1201

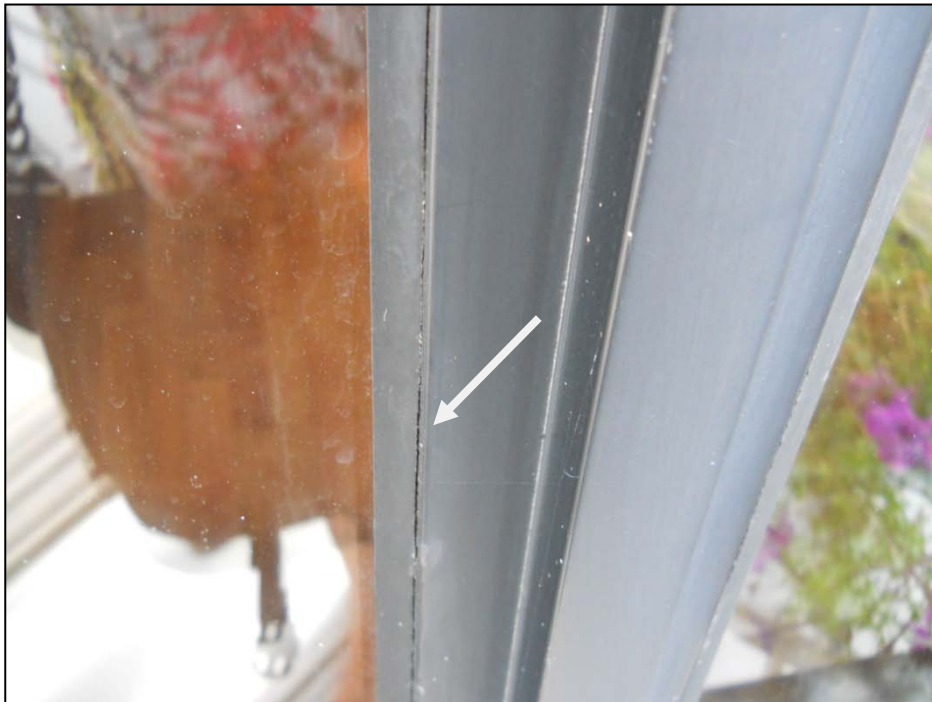
- An additional heel bead sealant was added at the glazing to frame junctions. In most cases this heel bead sealant has failed (Photograph 8).
 - The glazing reviewed was all stamped 1974 (original to construction).

Photograph No. 8: Added heel bead sealant failing - Suite 1201

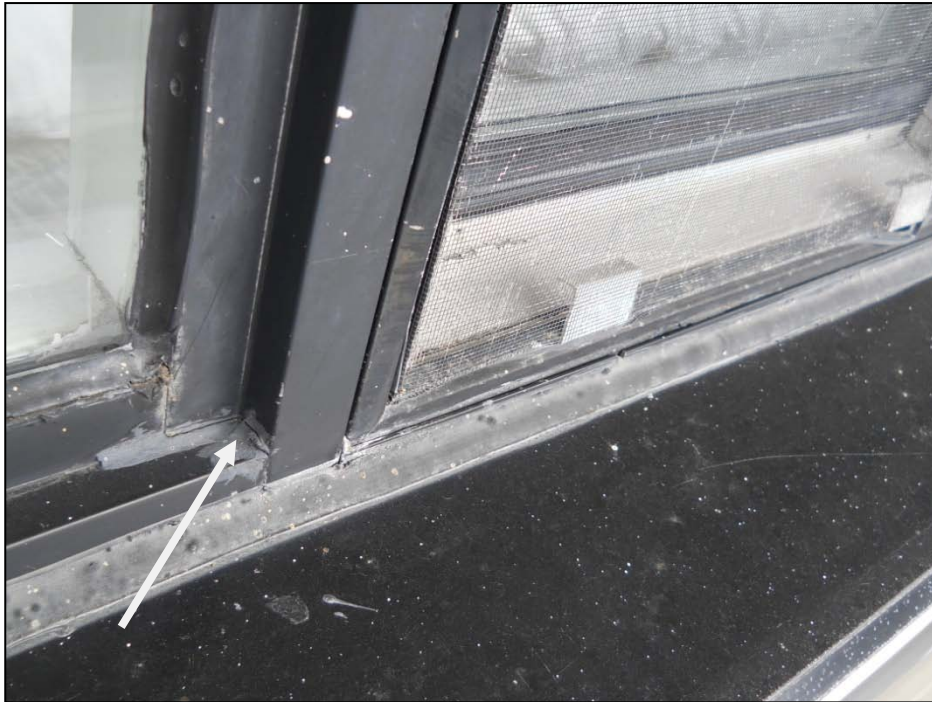
- The joints in the aluminum framing have opened up and there has been an attempt to seal these areas with sealant on the exterior (Photograph 9).
 - The frame for the bedroom operable window is bowed inward (Photograph 10).

**Photograph No. 9: Attempt to seal exterior joints
in aluminum frame - Suite 1201**

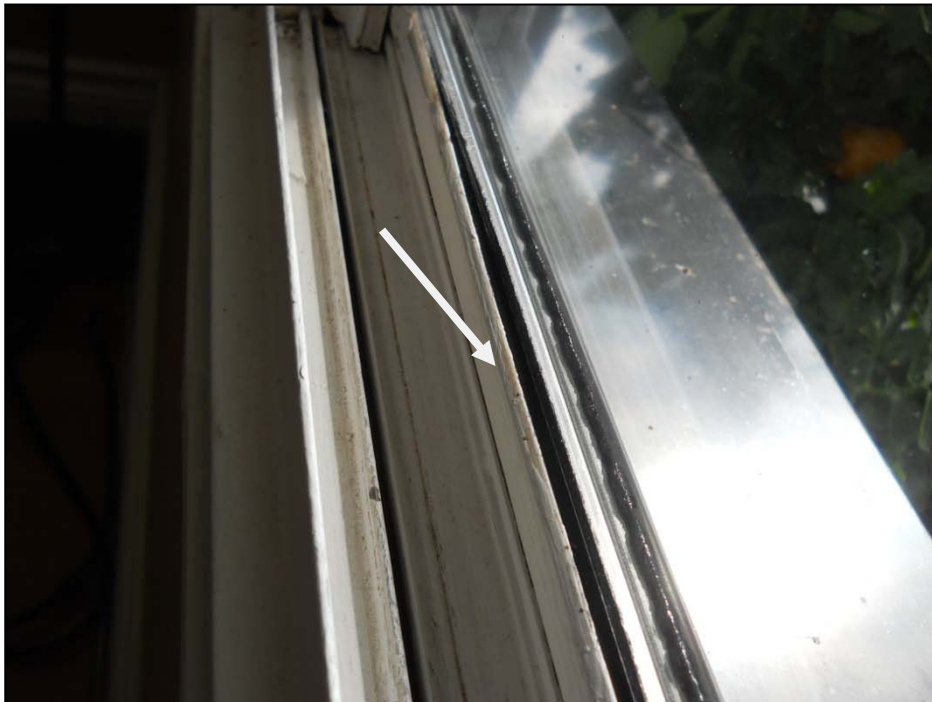
Photograph No. 10: Bedroom window frame bowed inward - Suite 1201

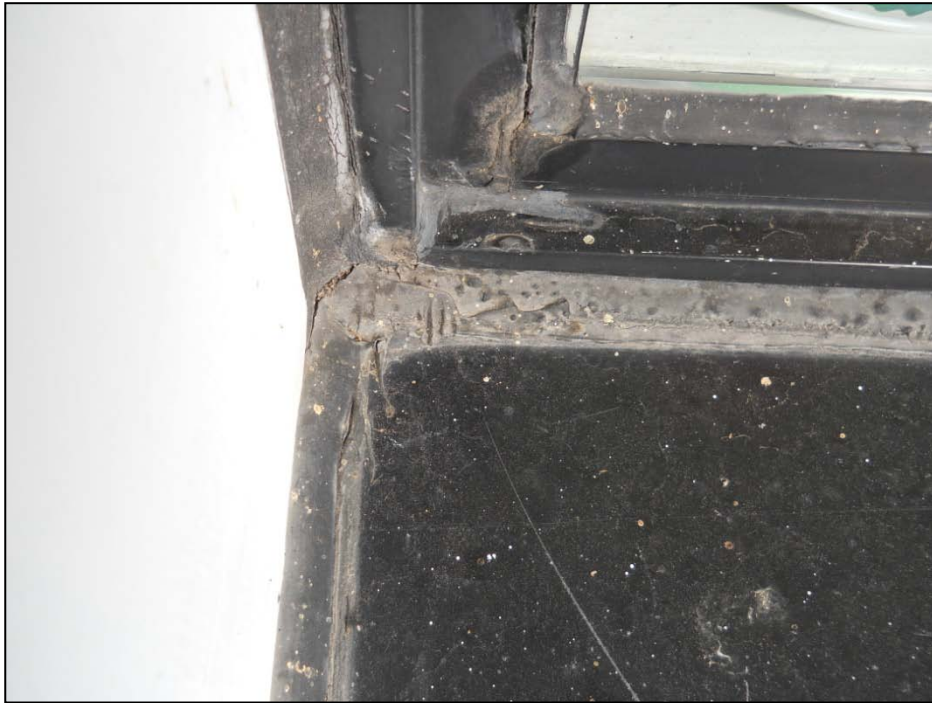
- The sealant at the frame-to-wall connection is brittle and cracked (Photograph 11). It appears that several layers of sealant have been added over the years in an attempt to stop the drafts and water leakage.

**Photograph No. 11: Sealant at frame-to-wall connection
brittle & cracked - Suite 1201**

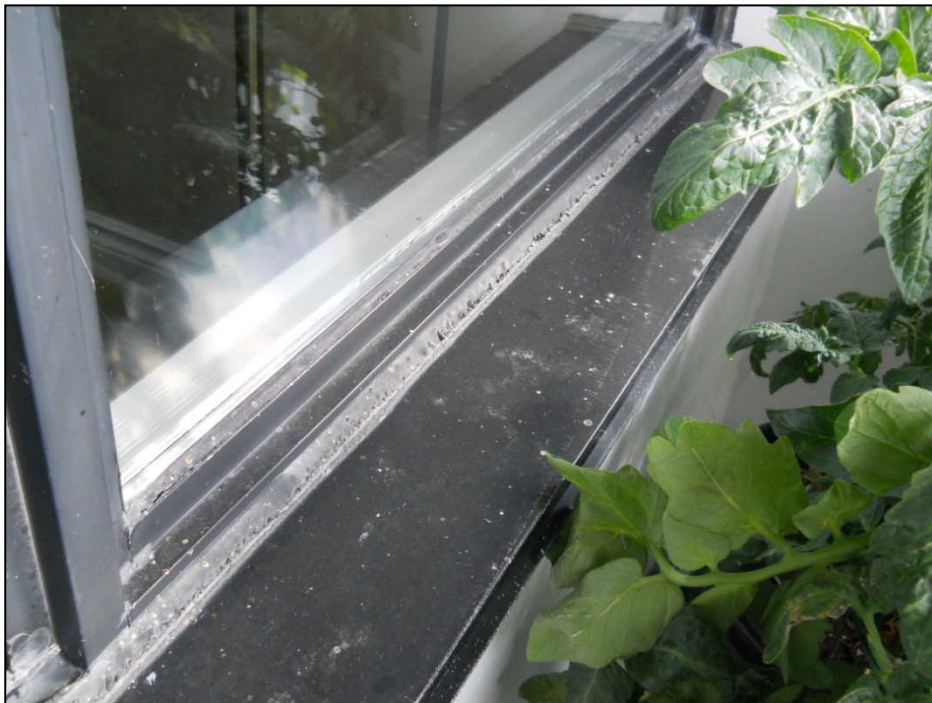
- The concrete sills were cracking and delaminating and, as a result, they were covered with aluminium flashing (Photograph 12).
- The pool windows were also reviewed from the interior. These fixed windows are similar to the fixed windows throughout the building. The interior stop that supports the glazing was removed in one location. The following was noted when removing the stop:

**Photograph No. 12: Aluminum flashing added where there
was a cracked concrete sill – Suite 1201**

- It was noted that some of the exterior concrete sills below the windows are delaminated. It appears that supported metal flashing can be added over the sills without the requirement of concrete repairs.

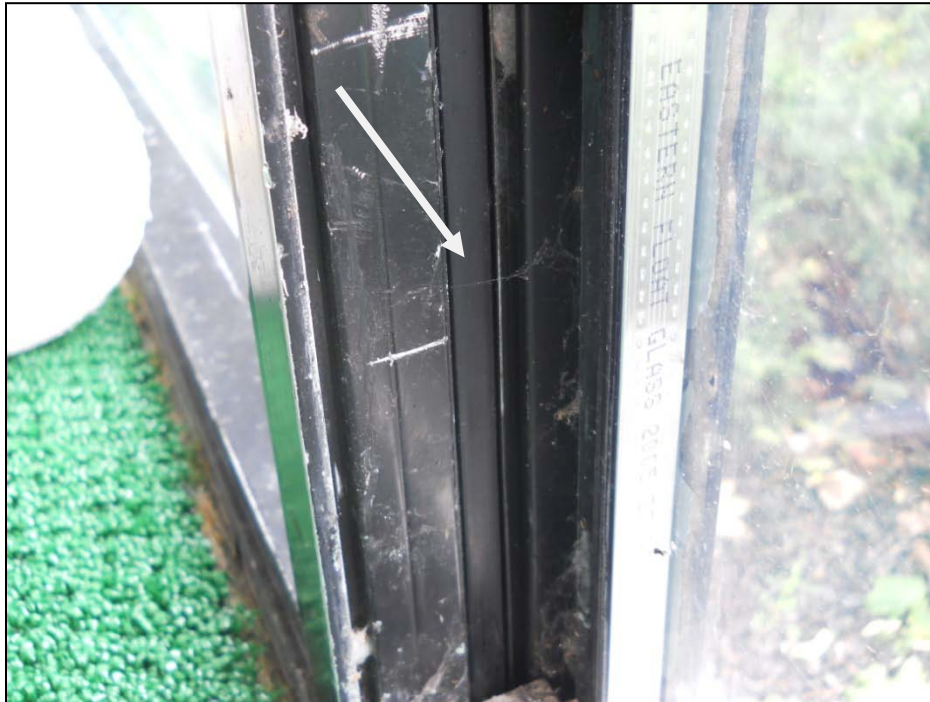
- The thermal break was interior of the glazing (Photograph 13); therefore, during the winter, the glazing is on the cold side of the thermal break making the window much colder. Typically in new window fabrication the glazing is aligned with the thermal break.

Photograph No. 13: Thermal break located at the interior of glazing

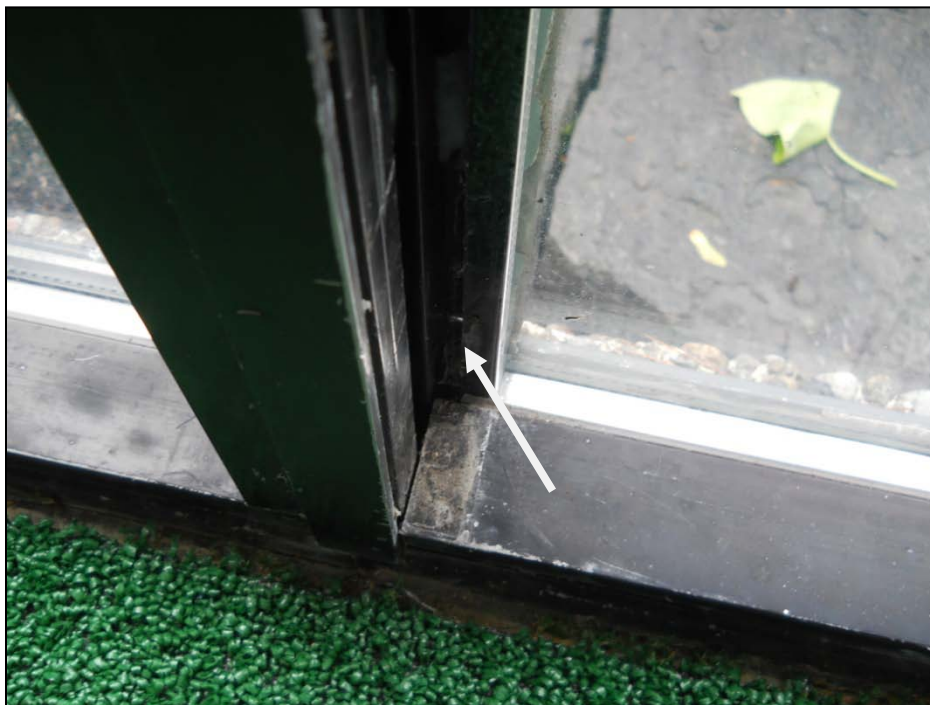
- Daylight could be seen at the frame-to-glass junction (Photograph 14).
- A follow-up review was performed on January 14 to collect information in order to better assess the cost for window and sliding door replacement. On this date, access was provided to the party room, swimming pool, and suites 101, 501, 702 and PH 3. The following was noted:

Photograph No. 14: Daylight visible through frame-to-glass junction - Pool

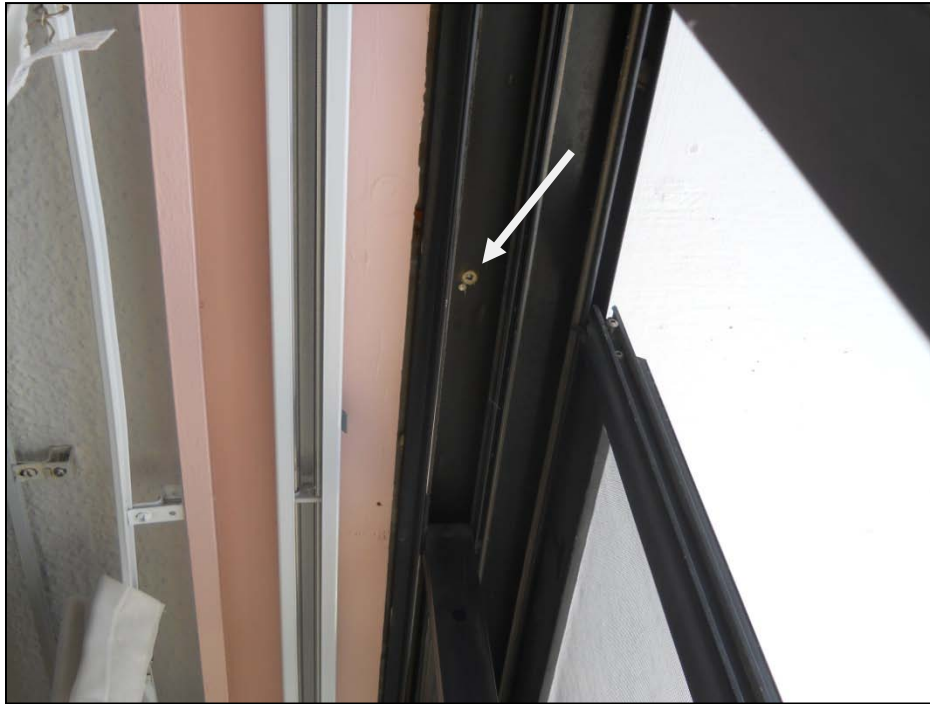
- It appears that the sliding door is anchored at top and bottom by a fastener through the frame into concrete (Photograph 15).

Photograph No. 15: Sliding door anchored into concrete slab

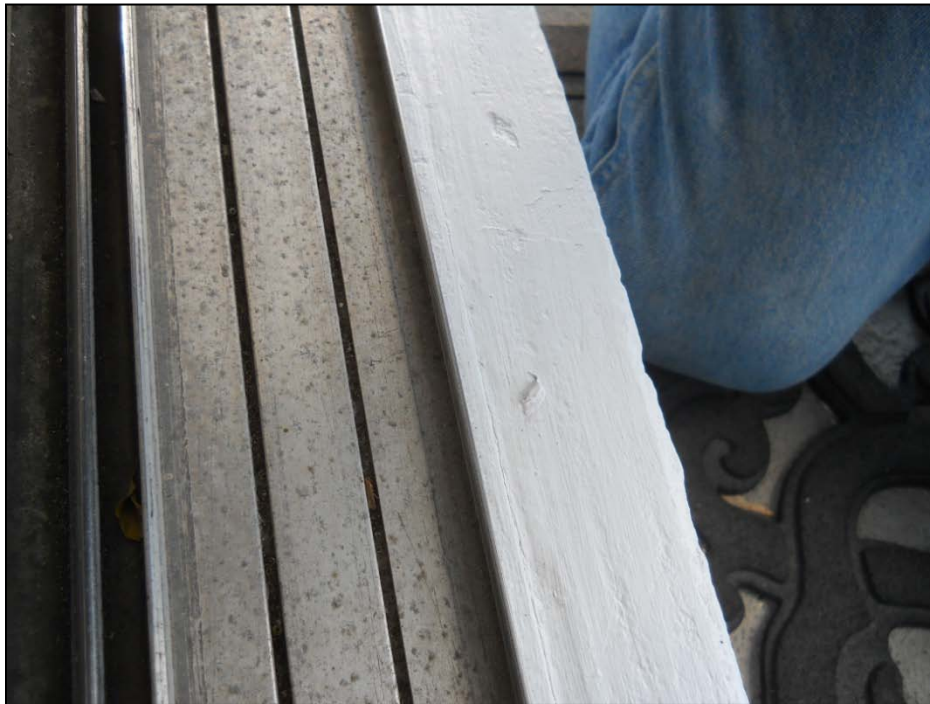
- The head of sliding door frames and the window frames are tight against the underside of the concrete floor slab.
- The sill of the sliding door is resting directly on the concrete curb above the balcony (Photograph 16).

Photograph No. 16: Balcony sliding door frame sits directly on concrete curb

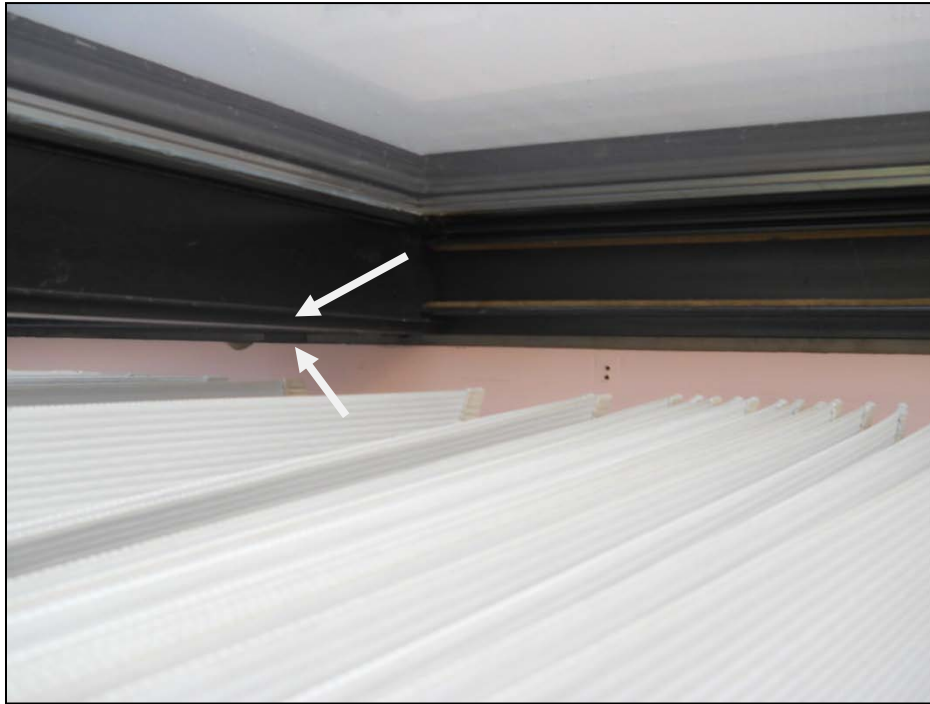
- At the head of the fixed windows there are anchor clips to fasten the window (Photograph 17). During installation in circa 1974, the anchoring clips were first fastened to the window frame, the window was installed, and then the anchoring clip extension was fastened to the underside of the concrete floor slab. These anchor clips are partially covered with the wood valances above the windows. It appears that a portion of the wood valances will have to be removed in order to remove the old windows and to install new wider-framed windows.

Photograph No. 17: Anchor clips fastening at fixed windows

We also observed that the existing window anchoring clips can be cut and left behind the drywall. New anchoring clips can then be installed.

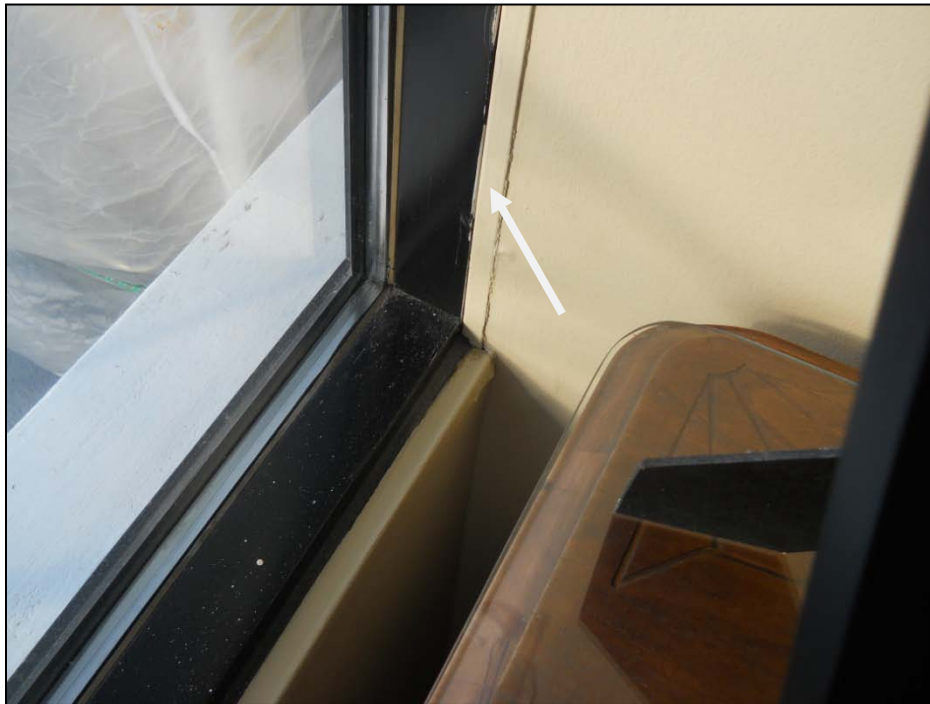
- The penthouse suites have higher floor-to-ceiling height and therefore have larger window sections.
- At the jambs, it appears that the metal track supporting the wall gypsum board is screwed directly to the window frame stop (Photograph 18). If the glazing seal were to fail at these windows directly adjacent to the walls a portion of the gypsum board would have to be removed in order to remove the interior glazing stop that supports the glazing.

Photograph No. 18: Gypsum metal track fastened into window frame stop

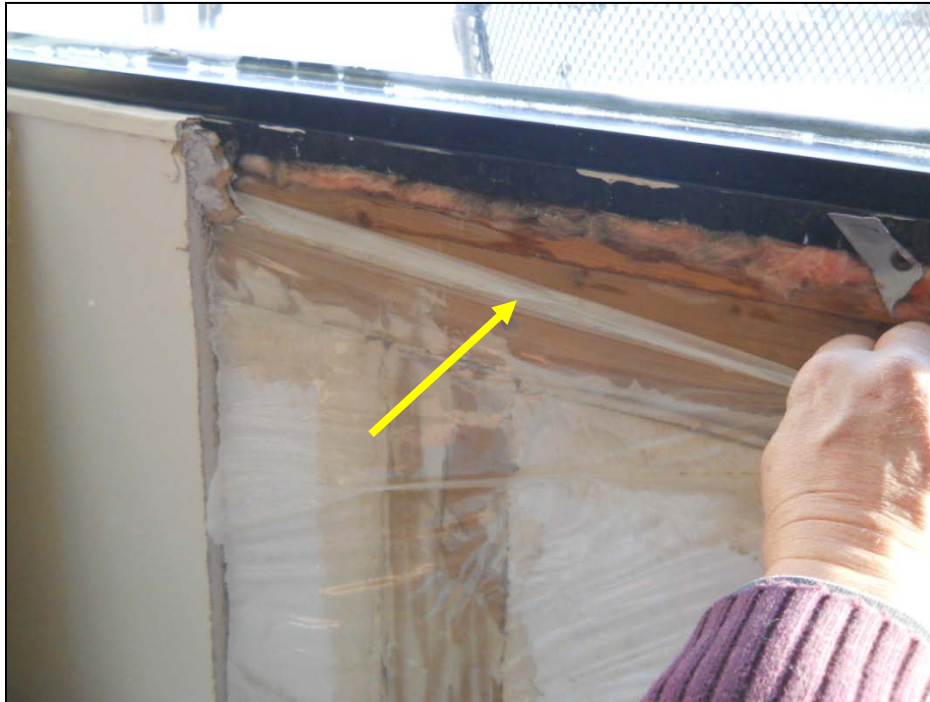
- ½" gypsum board
- Polyethylene (very thin) (Photograph 19)
- 1 ½" Expanded Polystyrene Insulation (beadboard)
- 6½" Concrete (Photograph 20)

Photograph No. 19: Polyethylene Vapour Retarder (very thin)

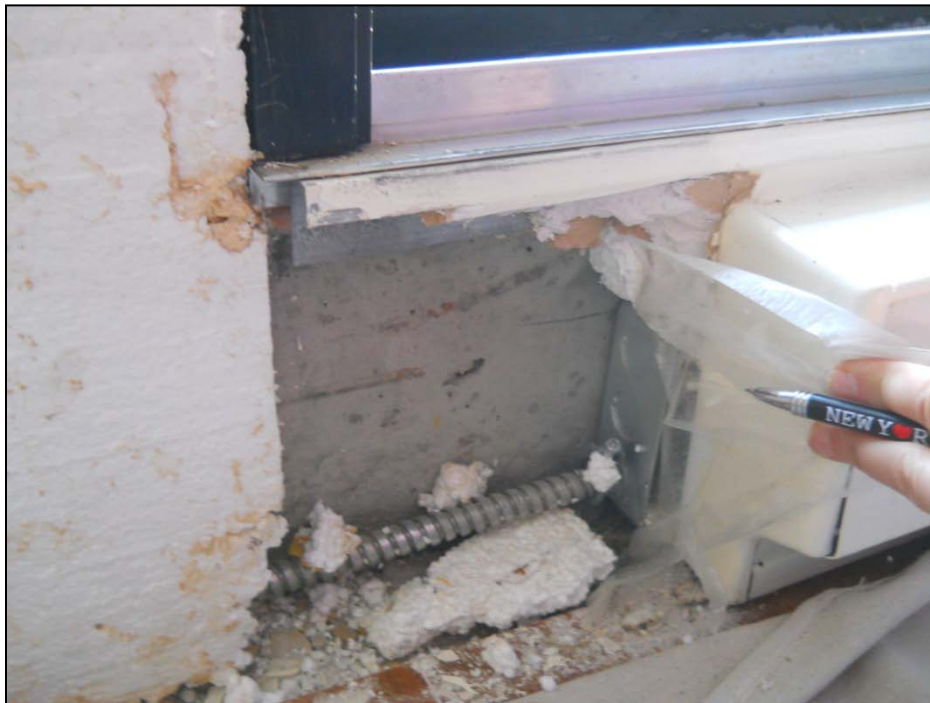
- There is electrical conduit within the area of the insulation at the base of the insulation (see Photograph 20).
- The gypsum board metal cap was fastened directly to the frame of the window at the sill.

Photograph No. 20: Exposed 6½" concrete & electrical conduit

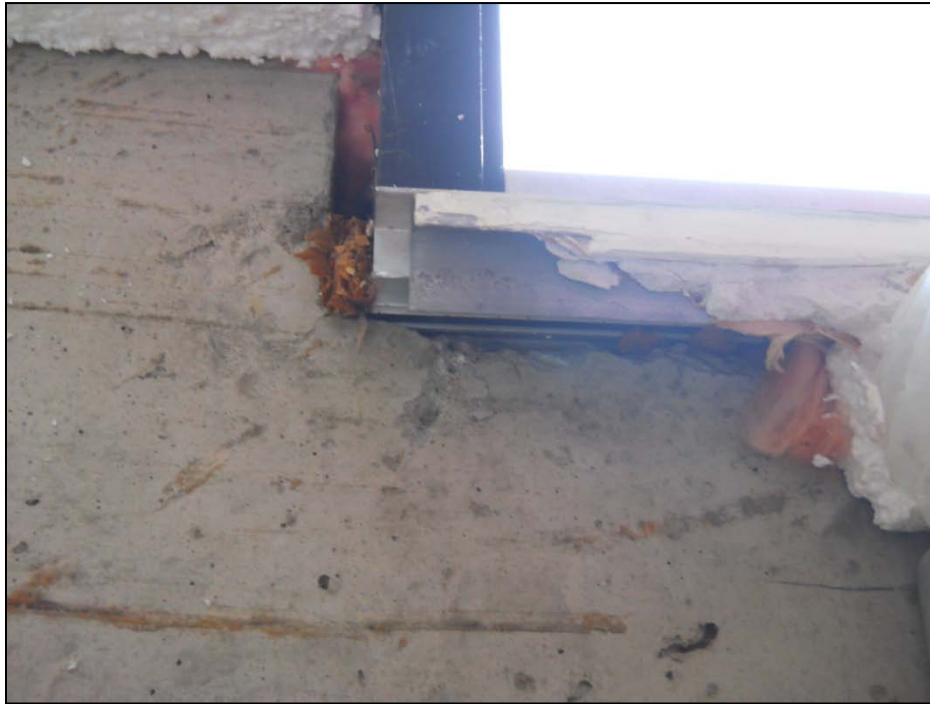
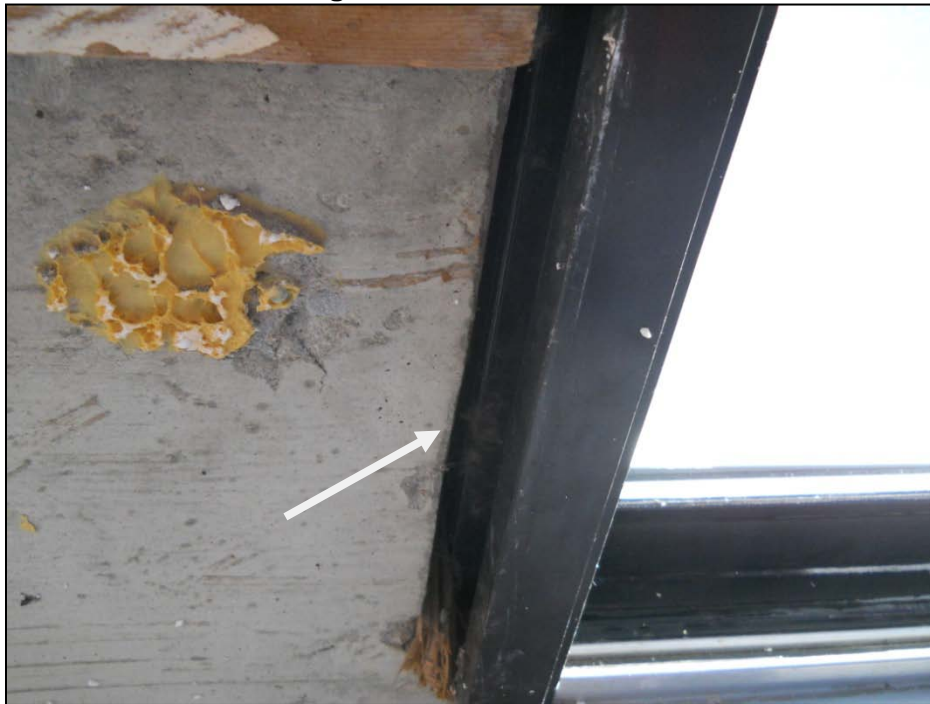
- Below the sliding doors, between the sliding door and concrete curb, and adjacent to the sliding door, there is almost no insulation and no measures to make the sliding door air tight to the wall (Photographs 21 and 22).

Photograph No. 21: Limited insulation present between sliding door sill & concrete curb

Photograph No. 22: No insulation present between sliding door frame & concrete

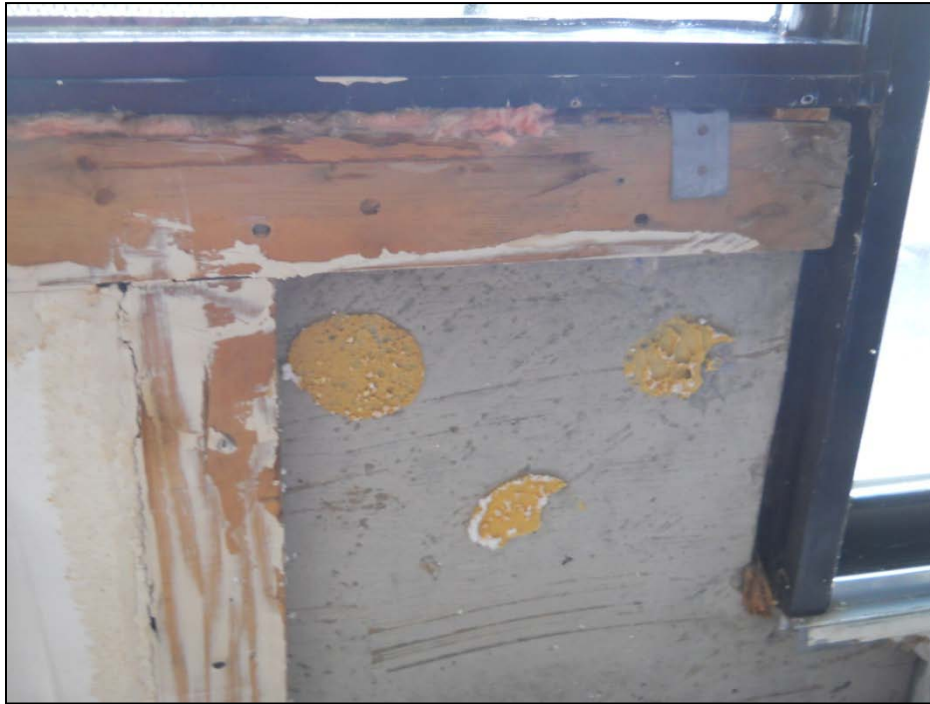
- It was confirmed that the sliding door is fastened directly to the concrete curb through the sill of the sliding door.
- Below the fixed window frame there is a nominal 2" by 4" wood stud (actual size 1½" by 3½") (Photograph 23). This wood stud is fastened directly to the exterior concrete. Anchor clips are used to fasten the window frame to the wood stud.

Photograph No. 23: 2" x 4" wood stud below fixed window frame

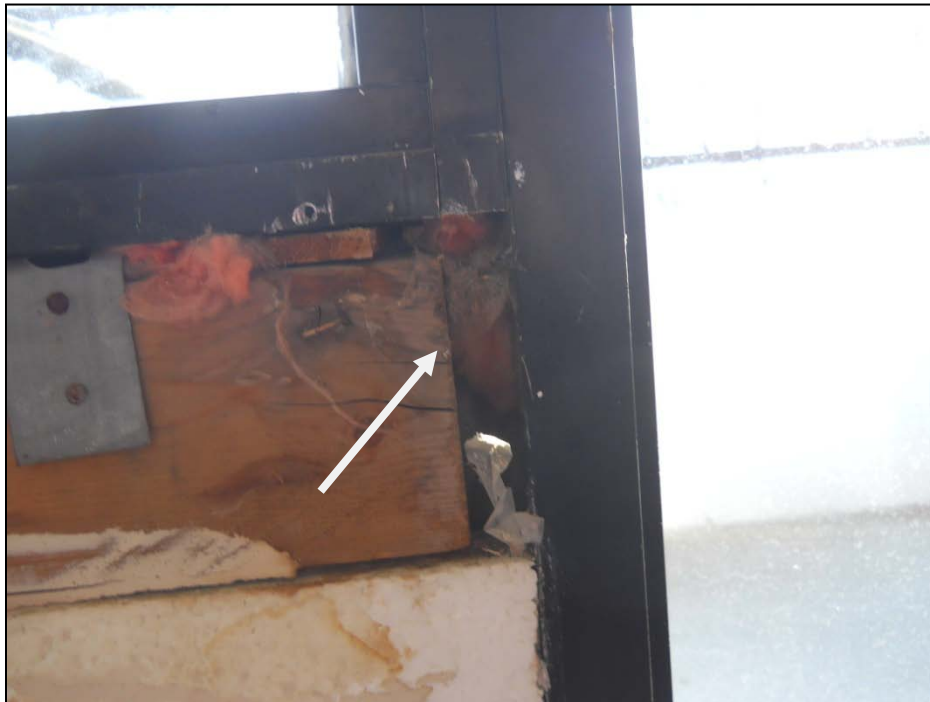
- There is some fibreglass insulation pushed between the window frame and the exterior concrete (Photograph 24). The only element that made the connection air tight from the concrete sill to the window frame was the exterior sealant (which was in poor condition). Air could be felt coming through.

Photograph No. 24: Fibreglass insulation pushed between window frame & exterior concrete

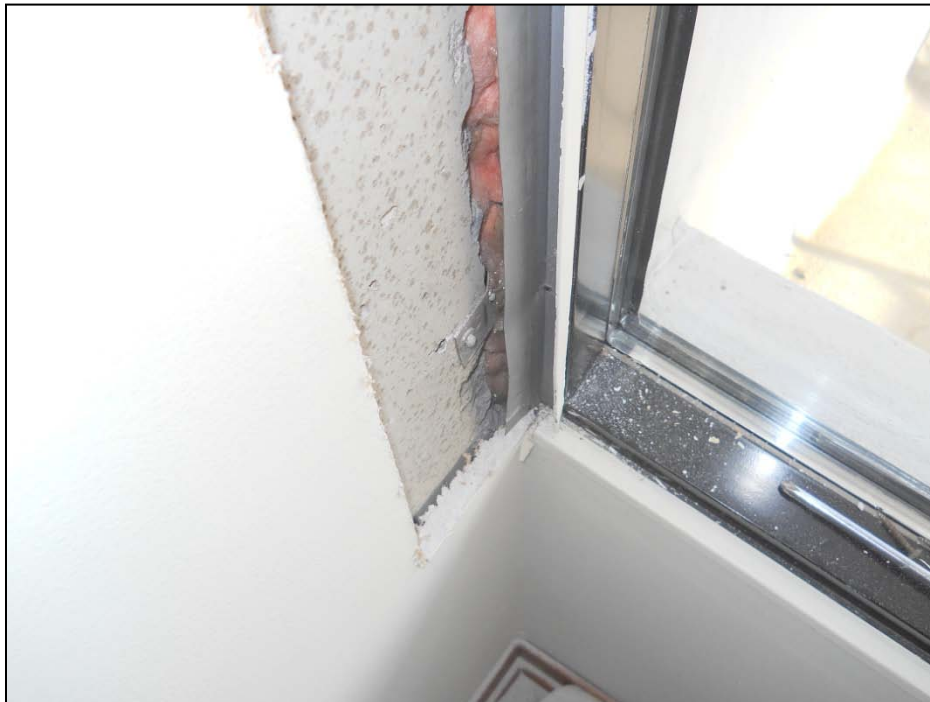
- At the window jam adjacent to the building concrete shear walls, the concrete needed to be chipped out in order to accommodate the window (Photograph 25).

Photograph No. 25: Concrete chipped out to accommodate for window frame
