Scrub Rattle Bang Bang

By Gordon Koppang

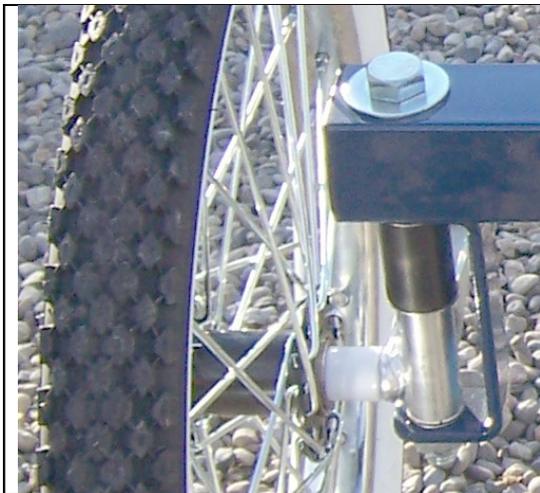
The kingpin bolt as it passes through the frame, the rubber damper and the spindle. Visible at the bottom of the spindle is a white ring of plastic.

This picture was taken when the bike was fresh out of the crate.

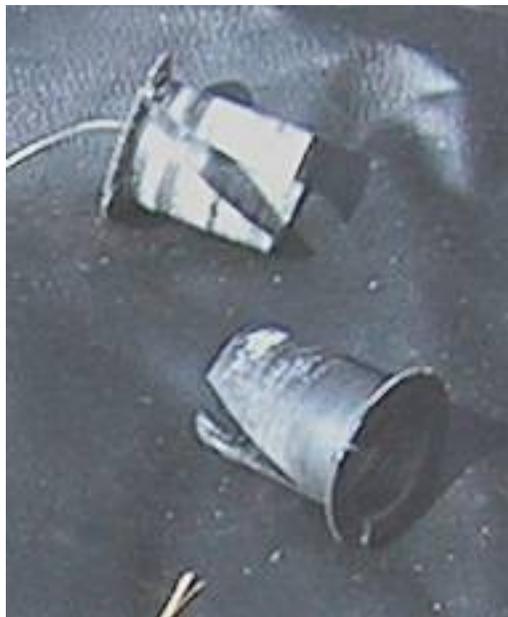
Here are the plastic bushings located at the top and bottom of the spindle. They're not thick enough to stabilize the spindle on the kingpin bolt.

The kingpin bolt has a $5/8^{\text{th}}$ outside diameter. The inside diameter of the spindle measures $11/16^{\text{s}}$. That $1/16^{\text{th}}$ inch gap is only partly filled by the plastic bushings. The

uncontrolled movement of the spindle on the kingpin bolt translates into a hellish amount of uncontrolled wheel movement. How can a little bit of play on the kingpin bolt result in so much wheel movement?

Scott's temporary solution was to place plastic bushings on the kingpin bolt and wrap them good and snug with a few turns of masking tape. Then he put the fattened-up bushings back in the spindle. I believe the permanent solution is to replace the tape with a material called "shim stock." It comes in sheets of various thicknesses and is usually made of brass, bronze, or nylon. When putting everything back together, we added a washer between the bottom of the spindle and the bracket that it's bolted into. This reduced the uncontrolled up and down movement of the spindle on the kingpin bolt.

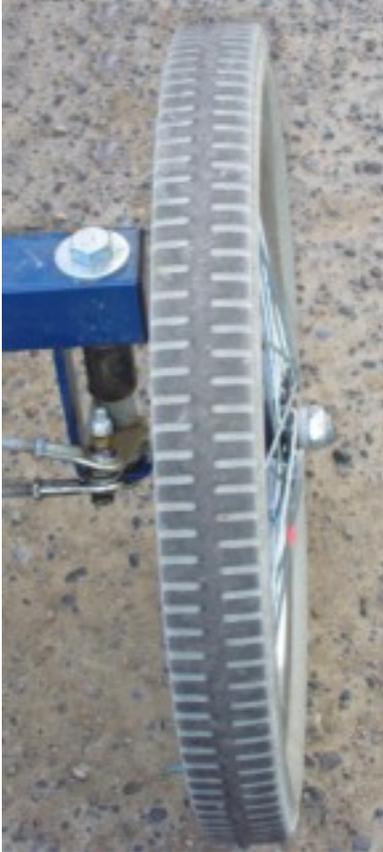
A small rocking motion of the spindle and axle translates into a much larger motion when measured at the outer circumference of the tire.
